Report No. 10075

DEVELOPMENT OF ANTENNA GROUP OA-1227(XE-1)/TPS

Final Technical Report
25 June 1957 to 1 May 1961

HAZELTIME ELECTRONICS DIVISION

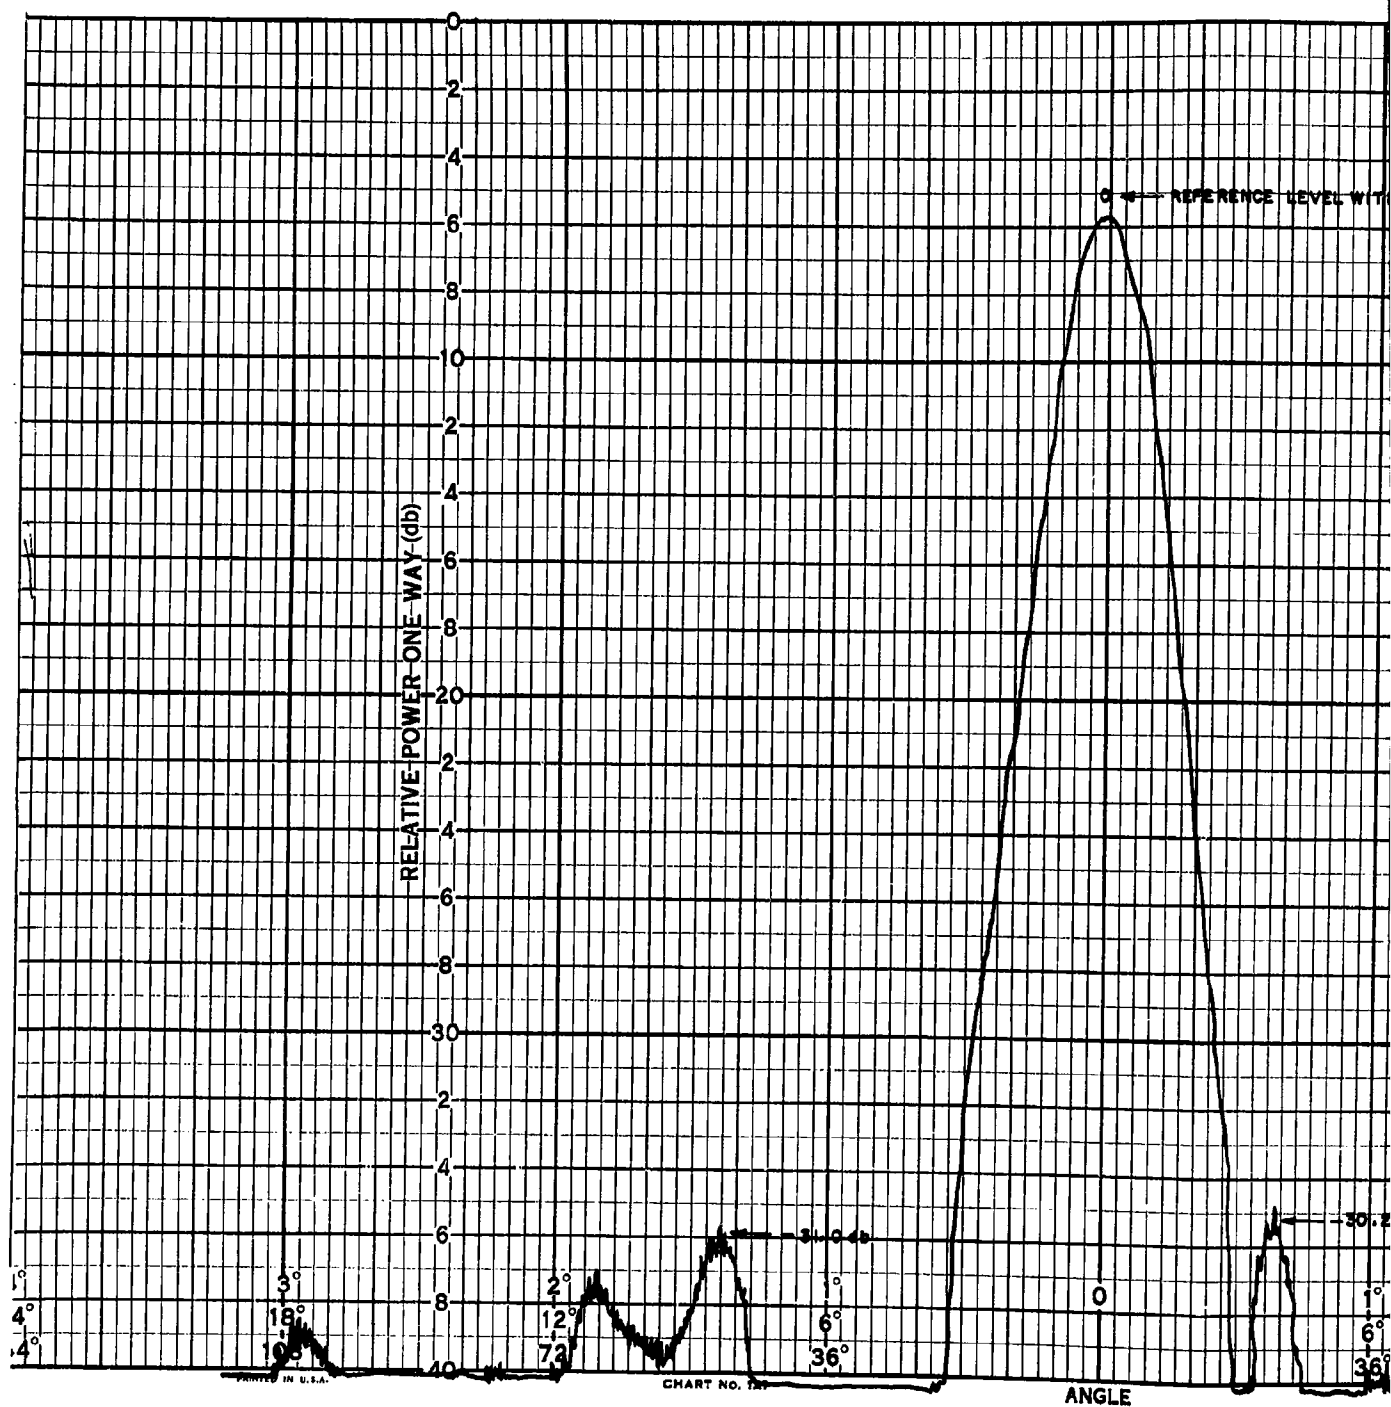
Figure B10. Azimuth Side Lobe Pattern, 1° Down Tilt
